Manhole Inspection Summary

Manhole # S23M__025MH

Insp Date: **6/17/08 9:27 AM**

Location Address: **S Stricker St**

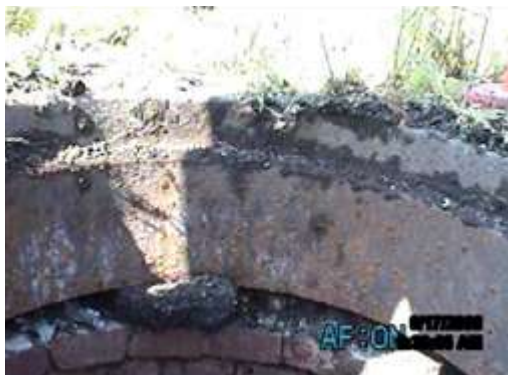
Miscellaneous

Frame Offset: **0** (in.) Condition: ☐ Sound ☐ Cracked ☒ **Leaks**

Infiltration: ☐ None ☒ **Joint** ☐ Cracks ☐ Mortar ☐ Roots ☐ Wall

infiltration lid-frame-chimney joints

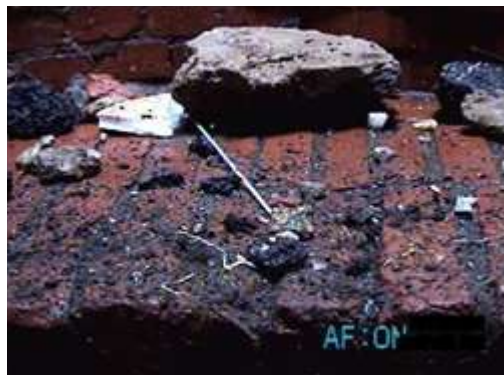
Miscellaneous

bench debris

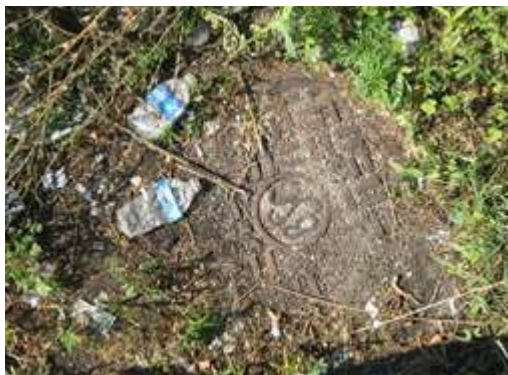
Miscellaneous

MH Cover

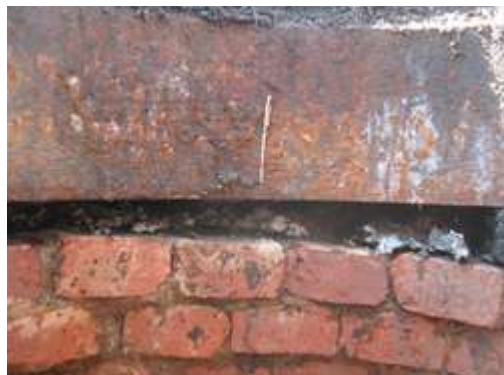
Defect 4

Condition: ☐ Sound ☐ Cracked ☐ Root Intrusion ☒ **Loose Brick** ☐ Deteriorated

loose bricks in chimney & infiltration from joint

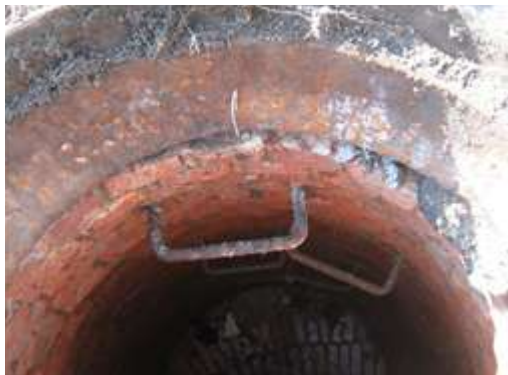
Defect 3

Steps Count: **6** Missing: **0** ☒ **Corroded**

lid-frame infiltration, corroded steps

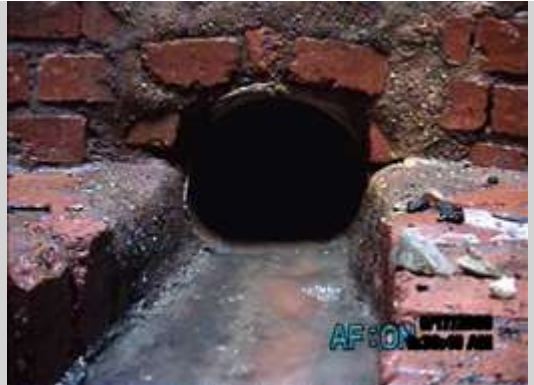
12 O'Clock Outflow

Pipe Height: **8.4** (in.) Rod and Bar (Angled)
Pipe Material: **Clay** ☐ Pipe Lined
Invert Depth: **9.29** (ft.) Flow Characteristics: **Fast**
Deposits: ☒ None ☐ Mud ☐ Sludge ☐ Debris ☐ Grease
Silt Depth: **0** (in.) Deposits Extent:
Infiltration: **None** Pipe Seal Cond: **Sound**

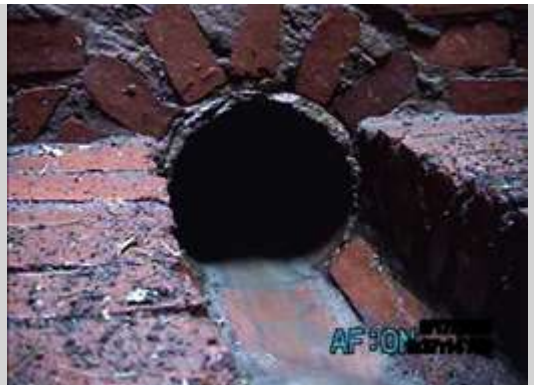
7 O'Clock Inflow

Pipe Height: **8.4** (in.) Rod and Bar (Angled)
Pipe Material: **Clay** ☐ Pipe Lined
Invert Depth: **9.20** (ft.) Flow Characteristics: **Fast**
Deposits: ☒ None ☐ Mud ☐ Sludge ☐ Debris ☐ Grease
Silt Depth: **0** (in.) Deposits Extent:
Infiltration: **None** Pipe Seal Cond: **Sound**
